# New Hampshire Volunteer Lake Assessment Program

## 2002 Interim Report for Webster Lake Franklin

# Webster Lake, Franklin

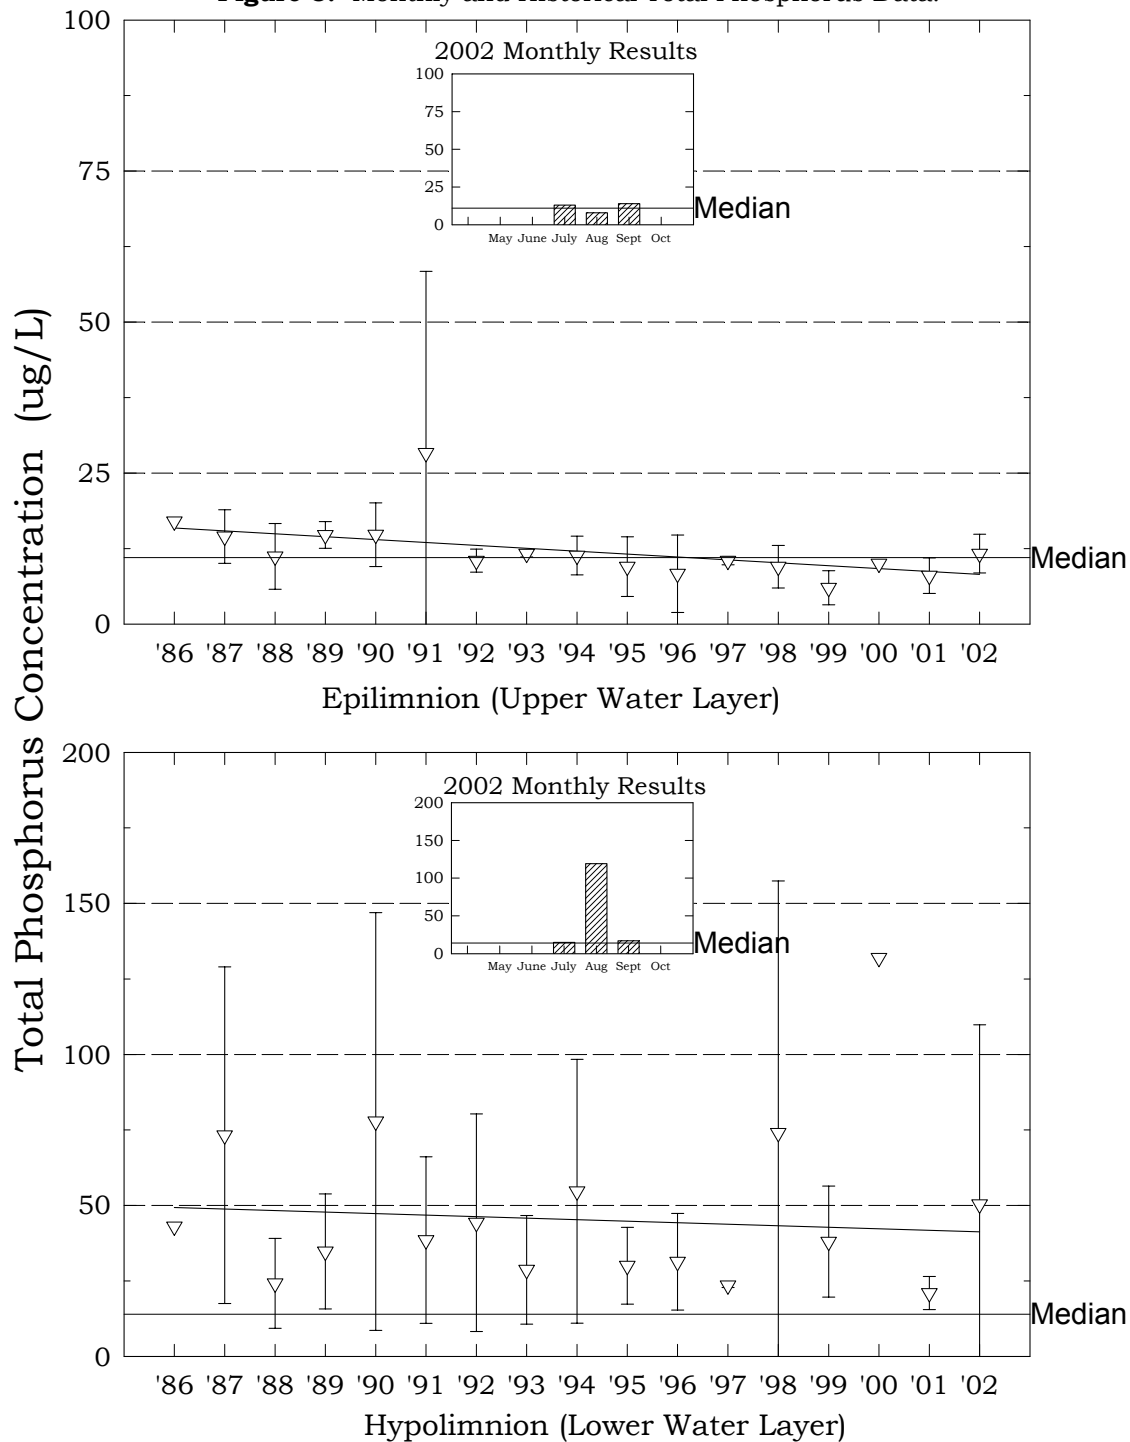
**Figure 3.** Monthly and Historical Total Phosphorus Data.

- **Figure 3 and Table 8:** The graphs in Figure 3 (Appendix A) show the amounts of phosphorus in the epilimnion (the upper layer) and the hypolimnion (the lower layer); the inset graphs show current year data. Table 8 (Appendix B) lists the annual maximum, minimum, and median concentration for each deep spot layer and each tributary since the lake/pond has joined the program.

The historical data for the epilimnion (the upper graph) show that the 2002 total phosphorus mean is **approximately equal to** the state median. Overall, visual inspection of the historical data trend line for the epilimnion shows **a slightly decreasing** total phosphorus trend, which means that the concentration has **slightly improved** since monitoring began.

The historical data for the hypolimnion (the lower graph) show that the 2002 total phosphorus mean is **much greater than** the state

median. (Note: This is due to the elevated phosphorus concentration in **August**. The turbidity of the hypolimnion (lower layer) sample was also elevated on this sampling event. This suggests that the lake/pond bottom may have been disturbed by the anchor or by the Kemmerer Bottle while sampling. When the lake/pond bottom is disturbed, sediment, which typically contains attached phosphorus, is released into the water column. When collecting the hypolimnion sample, please check to make sure that there is no sediment in the Kemmerer Bottle before filling the sample bottles.)

Overall, visual inspection of the historical data trend line for the hypolimnion shows **a variable** total phosphorus trend, which means that the concentration has **fluctuated** since monitoring began.

One of the most important approaches to reducing phosphorus loading to a waterbody is to continually educate watershed residents about its sources and how excessive amounts can adversely impact the ecology and value of lakes and ponds. Phosphorus sources within a lake or pond's watershed typically include septic systems, animal waste, lawn fertilizer, road and construction erosion, and natural wetlands. If you would like to educate watershed residents about how they can help to reduce phosphorus loading into the lake/pond, please contact the VLAP Coordinator.
